Manhole Inspection Summary

Manhole # S45A2_002MH

Insp Date: **3/30/09 12:08 AM**

Location Address: **Shelby Ave.**

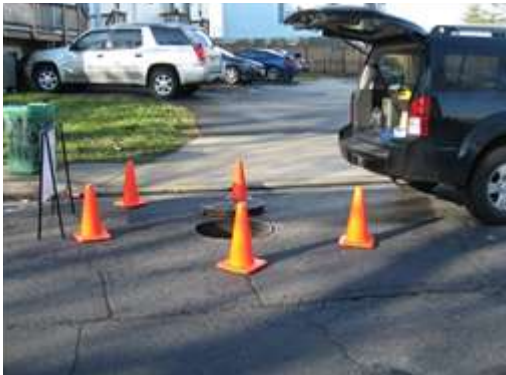
Location View

Shelby Ave.

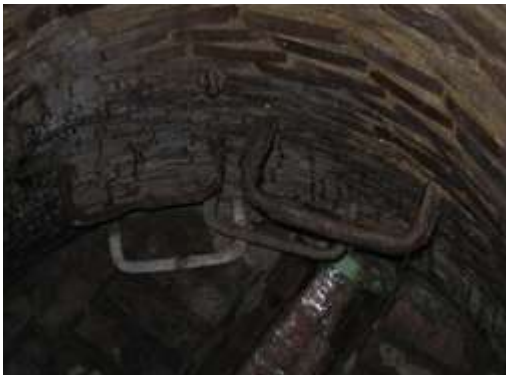
Steps Count: **5** Missing: **1** ☒ **Corroded**

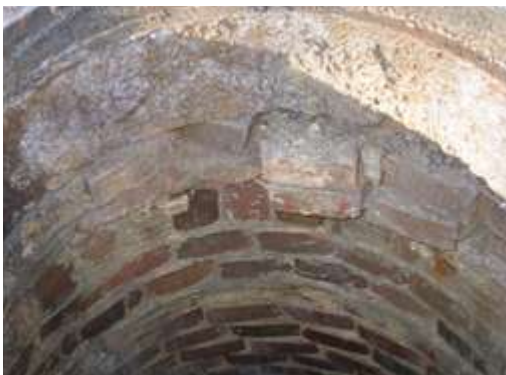
Defect 1

Condition: ☐ Sound ☐ Cracked ☐ Root Intrusion ☒ **Loose Brick** ☐ Deteriorated

Infiltration: ☐ None ☒ **Joint** ☐ Cracks ☐ Mortar ☐ Roots ☒ **Wall**

Infiltration

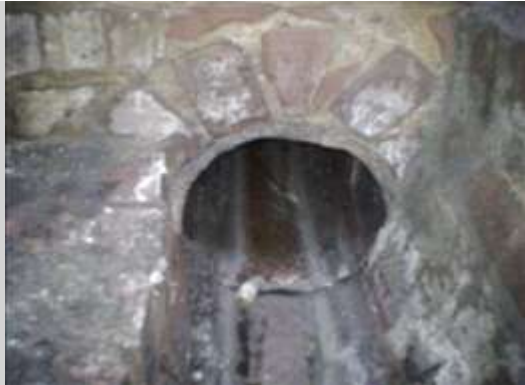
12 O'Clock Outflow

8 in. Circular Gravity Sewer
Pipe Out @ 12 O'Clock

Pipe Height: **10.8** (in.) Rod and Bar (Angled)
Pipe Material: **Clay** ☐ Pipe Lined
Invert Depth: **10.09** (ft.) Flow Characteristics: **Fast**
Deposits: ☒ None ☐ Mud ☐ Sludge ☐ Debris ☐ Grease
Silt Depth: (in.) Deposits Extent:
Infiltration: **None** Pipe Seal Cond: **Sound**

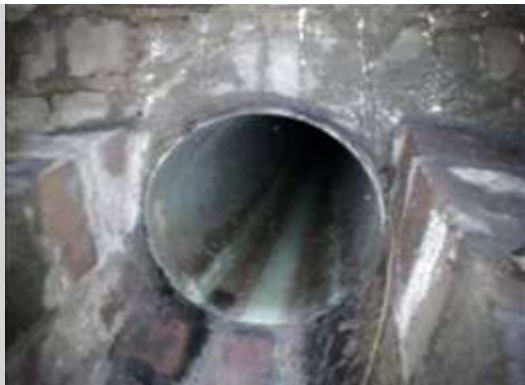
6 O'Clock Inflow

8 in. Circular Service Sewer
Pipe In @ 6 O'Clock

Pipe Height: **9.6** (in.) Rod and Bar (Angled)
Pipe Material: **PVC** ☐ Pipe Lined
Invert Depth: **8.71** (ft.) Flow Characteristics: **None**
Deposits: ☒ None ☐ Mud ☐ Sludge ☐ Debris ☐ Grease
Silt Depth: (in.) Deposits Extent:
Infiltration: **None** Pipe Seal Cond: **Sound**

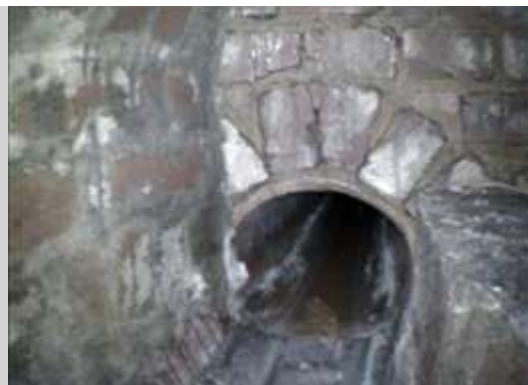
8 O'Clock Inflow

8 in. Circular Gravity Sewer

Pipe In @ 8 O'Clock

Pipe Height: **8.4** (in.) Rod and Bar (Angled)

Infiltration: **None** Pipe Seal Cond: **Sound**
